Forklift Operator Dies When Crushed between Forklift Overhead Guard and Mast

Investigation: # 12WA015
Release Date: January 22, 2018
SHARP Report: # 52-42-2018

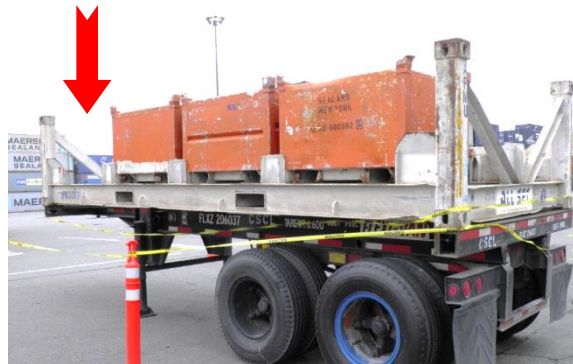
Photo 4: Cone bins set on flat racks loaded on to an intermodal chassis trailer. The arrow indicates the location of the bin that the victim had lifted and elevated on the forks of the forklift.

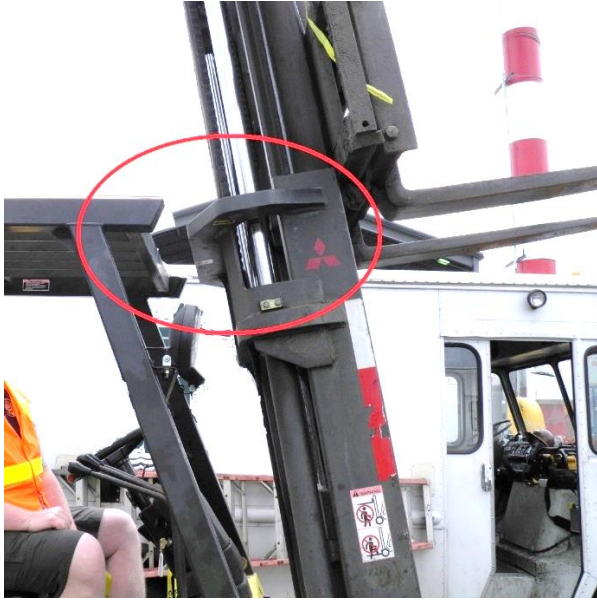
- It took 2 to 3 seconds for the mast to tilt to the full rearward position from a starting backward tilt position of 5 degrees.
- In the full rearward position the mast was approximately 1 inch from the plastic overhead guard cover and 4 inches from metal frame of the overhead guard.

- The mast cross member when in the full rearward position was 42 inches above the forklift dash. The overhead guard was also 42 inches above the dash.

- Fractures on the plastic cover of the overhead guard indicated that the victim was located near or just to the right of the forklift’s center line when his torso was crushed between the mast cross member and the overhead guard.

Photo 5: Forklift mast in the full tilted back position. The red circle indicates the area where the victim's torso was crushed between the cross member of the overhead guard and the mast.

Recommendation 1: Ensure that forklift operators never position themselves between the forklift operator's cab overhead guard and mast while the forklift is running.

Recommendation 4: Consider purchasing or equipping forklifts with an operator safety interlock device such as an Operator Presence Sensing System (OPSS) that prevents powered movement of the forklift, and its mast and forks when the operator is not seated properly at the controls.

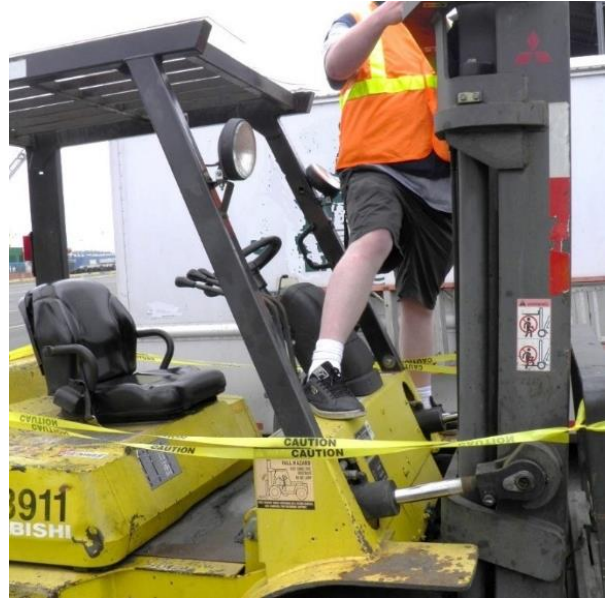
At 6:24 p.m., while operating the forklift, the victim approached a trailer loaded with four cone bins. He then used the forklift to elevate a cone bin approximately 2 feet above the flat rack mounted on the trailer. The forks were elevated to be about parallel with the top of the forklift's overhead guard. Leaving the forklift's engine running, he then left the operator's seat, climbed over the control console, and stood on the dash of the forklift between the mast and the overhead guard, presumably to look into the elevated bin and perhaps other bins on the trailer. His right foot moved backward and contacted the mast tilt control lever on the console. (The mast tilt lever controls the angle of the forks relative to the ground.) This caused the mast to tilt back, pinning his torso between the mast cross member and the overhead guard (photos 5–9).

Photo 6: A longshore worker demonstrates how the victim might have accessed the forklift's dash to look into the bin elevated on the forklift's forks. The victim was standing with both feet on the dash when his right foot inadvertently activated the forklift control on the dash that caused the mast to tilt backwards, crushing him against the operator's cab overhead guard.

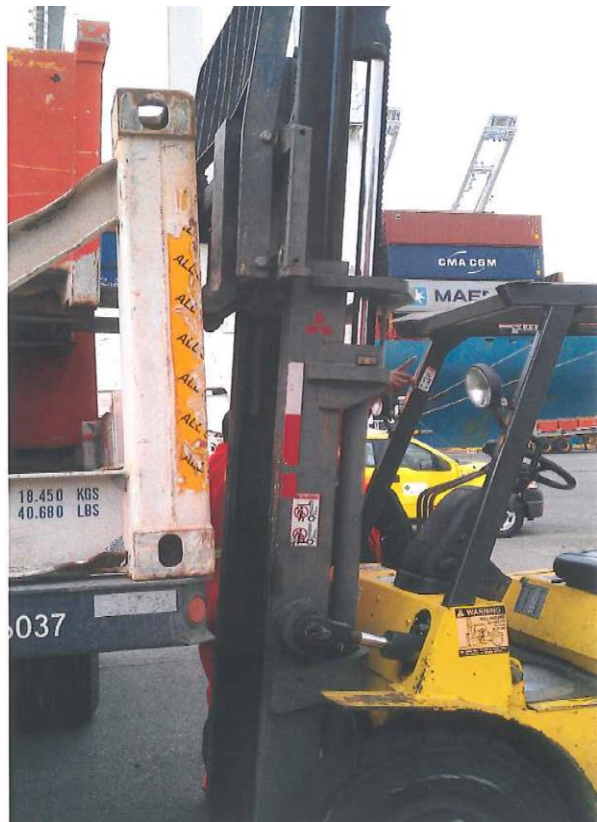
Photo 7: Recreation of the position of the forklift just before the incident. The forklift is next to the intermodal chassis trailer with a bin elevated on its forks. The victim climbed on to the forklift's dashboard between the mast and overhead guard to look into the bins on the trailer.

- Forklift was not operated safely in accordance with the manufacturer's operating manual.
- Forklift was not turned off or otherwise secured when the operator left the operator's seat.
- Forks were not lowered so that the operator could see the contents of the container bin.
- Consumption of alcohol by employee.

Recommendation 2: Ensure that standard operating procedures (SOP) are followed during forklift operation and review these procedures to ensure that they are effective in practice and revise if necessary.

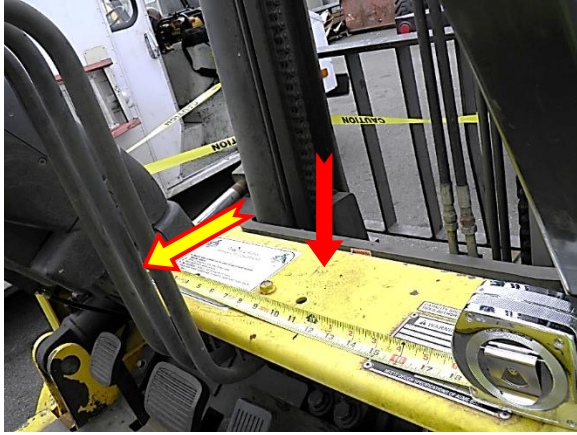
- The mast tilt control lever is about 1 ¼ to 1 ½ inches behind the top of the dash.
- Only a half-inch of movement of the mast tilt control lever was necessary to initiate and continue the rearward tilting of the forklift mast.

Photo 8: Forklift dash (red arrow) upon which the victim was standing when his foot inadvertently pushed against the mast tilt lever (yellow arrow). View is from inside the operator's cab.

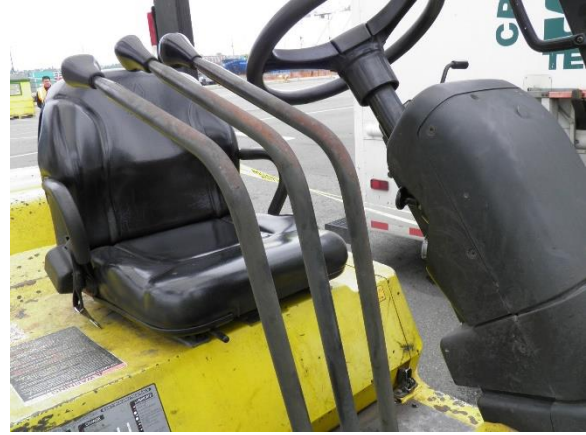
Photo 9: Forklift control levers used to adjust the forks and mast. The middle lever is the mast tilt lever.

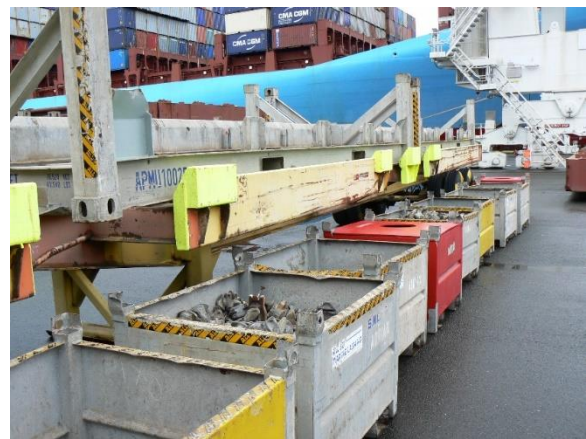
Photo 10: Cone bins on dock after corrective action by the employer was taken.

Following this incident, through an agreement between the longshore workers union and the employer, all bins are now routinely removed from the trailer mounted flat racks and placed on the dock. This

allows forklift operators to see into the bins while remaining seated in the forklift (photo 10).

cone bins on the dock. Based on this review an agreement was negotiated between the union and the employer requiring that all bins should be routinely removed from the trailer mounted flat racks and placed on the dock. This procedure allows forklift operators to see into the bins while remaining seated in the forklift. This abated the hazards associated with leaving the seat and climbing on the forklift and/or trailer.
