Company Co-owner Backed Over by Work Truck

REPORT #: 71-247-2023s

REPORT DATE: November 6, 2023

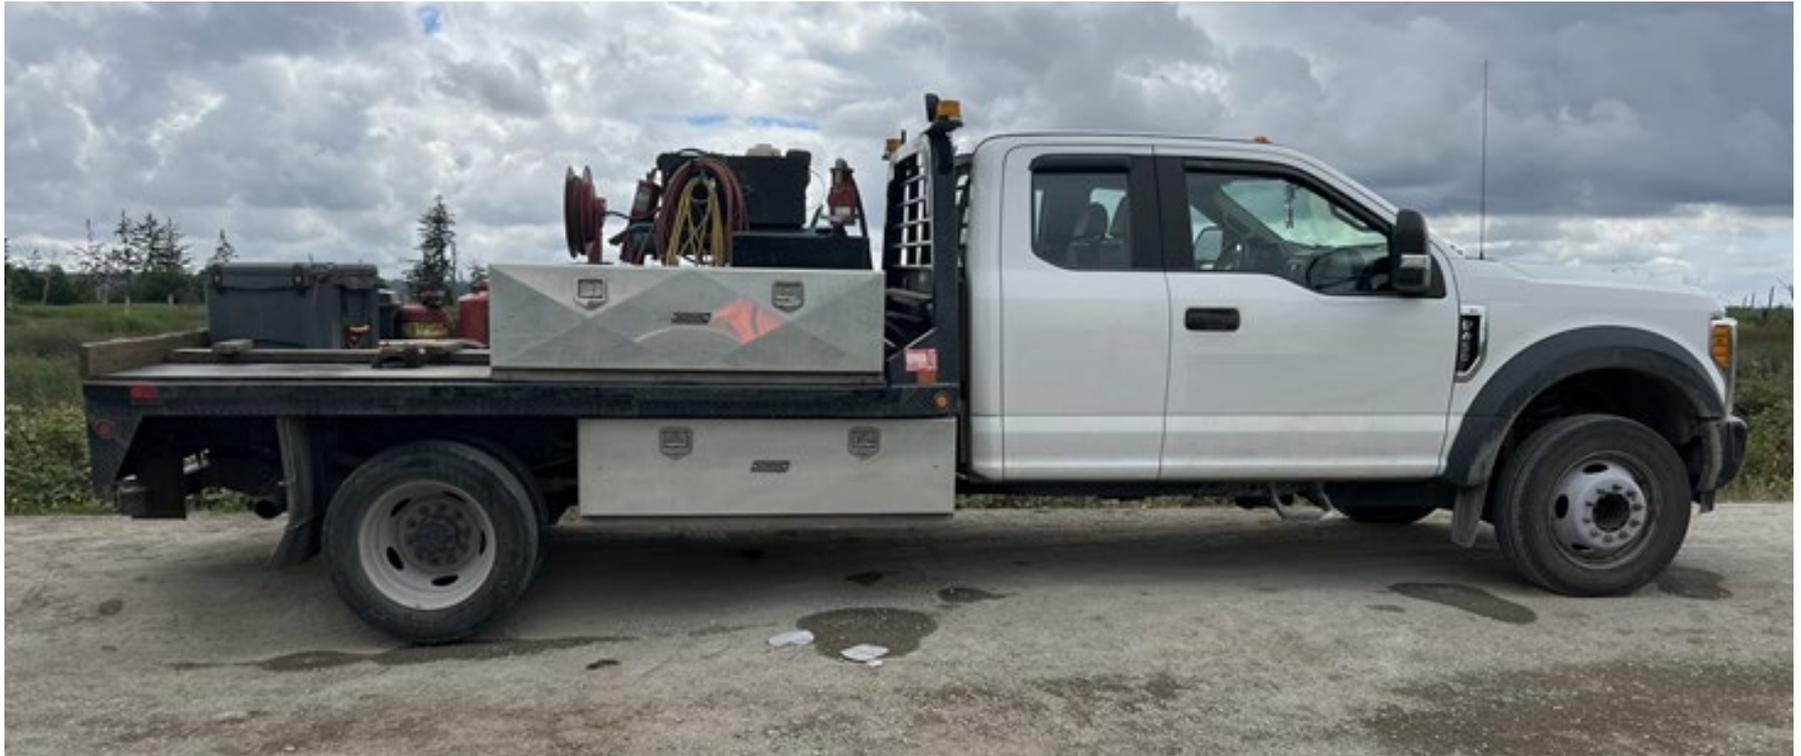
Photo 1. Heavy-duty work truck that backed over company co-owner.

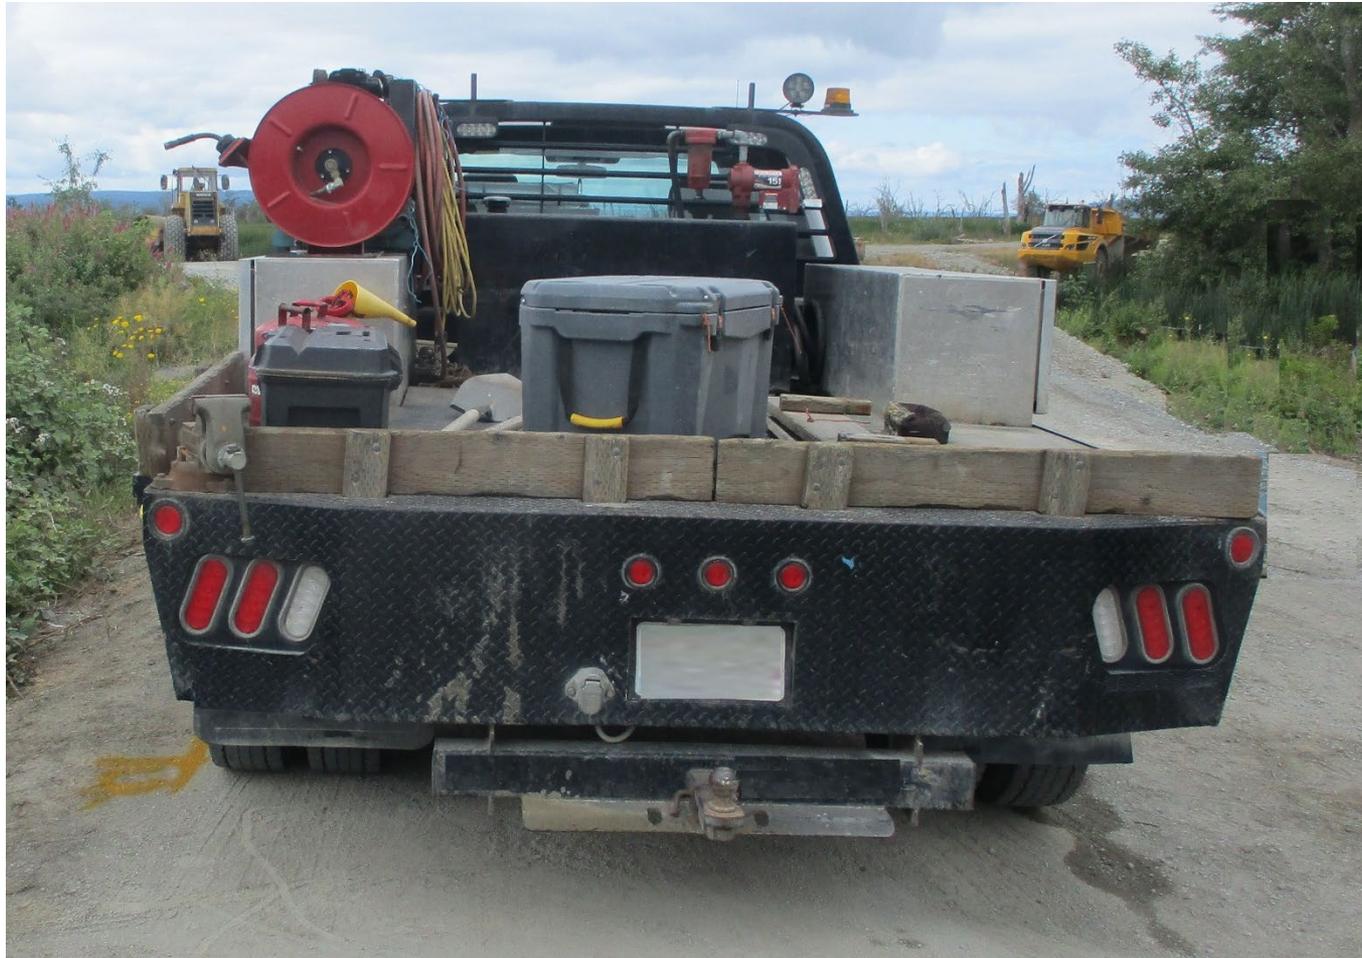
- The co-owner was wearing a hi-visibility vest, but the superintendent and passenger still did not see him in the truck's side and rear view mirrors or sense when he was struck.
- A steel tube headache rack and fuel transfer tank hose reel on the truck's flatbed deck partially obstructed visibility through the rear cab window.
- The work truck had not been inspected annually as required by federal motor carrier safety regulations.

Photo 2. Rear view of partially obstructed rear cab window.

- Create and enforce vehicle backing safety policies in their accident prevention program (APP) that:
 - Drivers maintain clear visibility of workers on foot. When visibility is lost, drivers should stop and not resume movement until visibility is re-established.
 - Workers stay out of backing zones unless trained and acting as an observer signaling the driver.
 - Prohibit workers on foot from using radios or phones when crossing roads when there is vehicle traffic.
- Increase availability of vehicle turnaround areas on construction site roads to minimize backing distances.

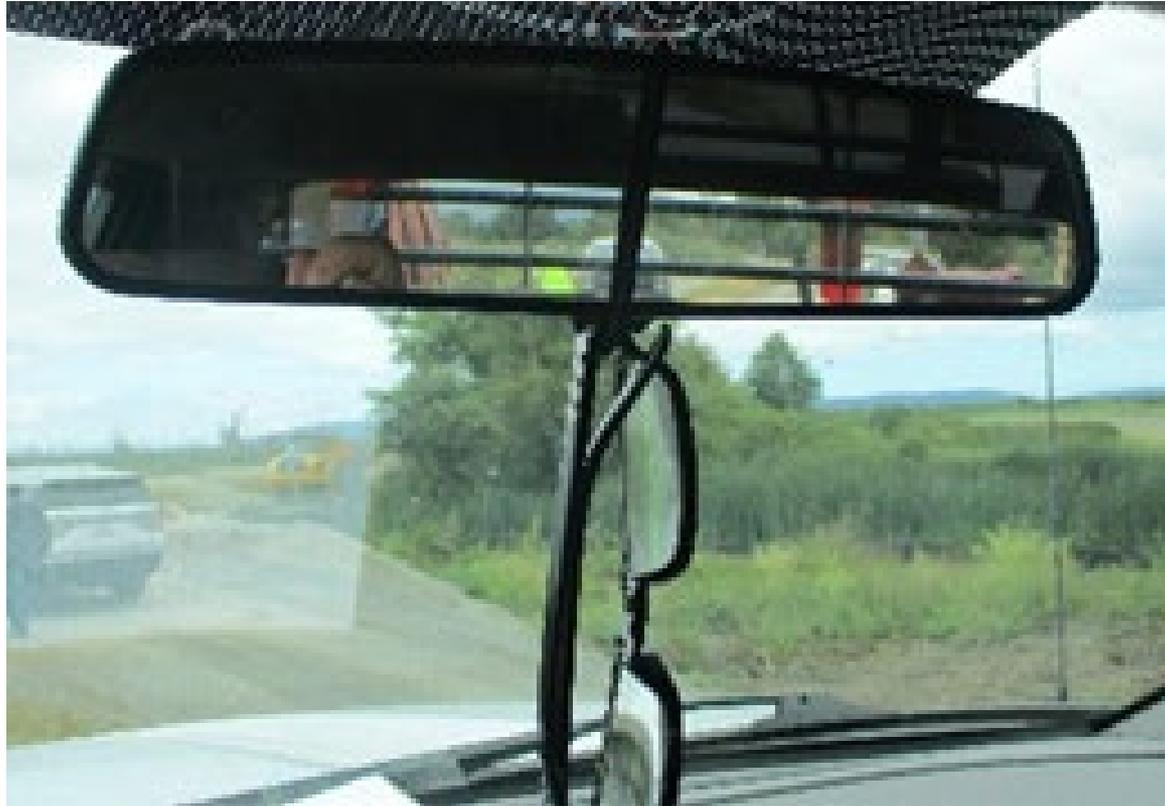
Photo 3. Visibility through the truck's rear view mirror was partially obstructed by a steel tube headache rack and fuel transfer tank hose reel that were mounted on the flatbed deck.

- When operating vehicles on construction sites, other than passenger cars and pickups, with an obstructed view to the rear: You must prohibit the use of any motor vehicle equipment that has an obstructed view to the rear unless the vehicle meets one of the following:
 - Has an operable automatic reverse signal alarm audible above the surrounding noise level and audible no less than 15 feet from the rear of the vehicle;
 - Or is backed up when an observer signals that it is safe to do so. See [WAC 296-155-610 \(2e\)](#)
- Comply with annual commercial motor vehicle inspection requirements according to [49 CFR 396.17](#).
