# Owner Crushed Loading Log Skidder on Lowboy Trailer

**REPORT #:** 71-248-2023s

**REPORT DATE:** December 11, 2023

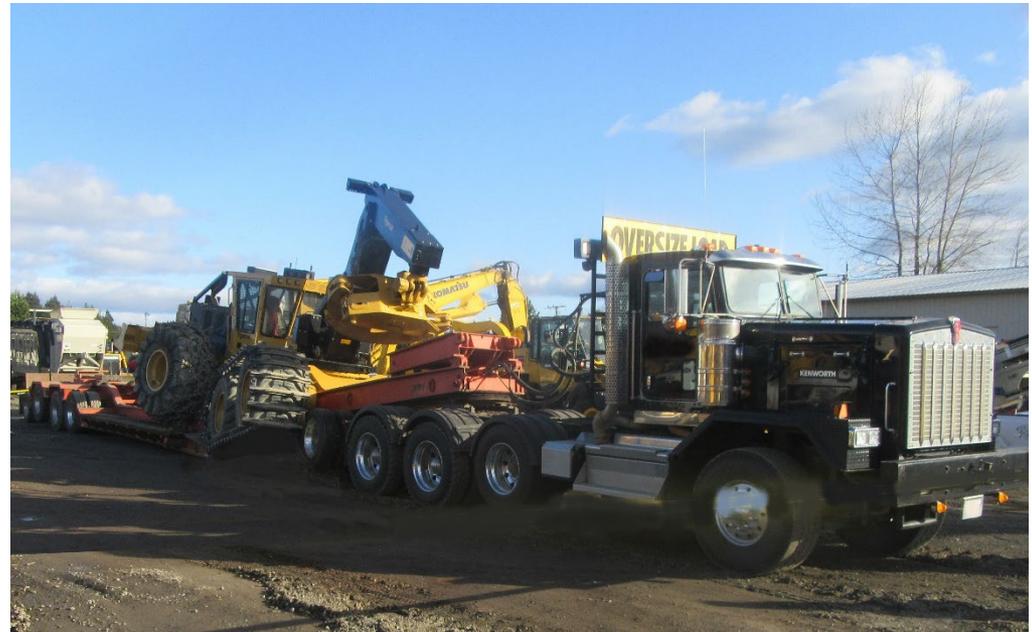
A 52-year-old logging company owner was crushed while helping to load a log skidder onto a detachable lowboy trailer. He was a logger for much of his life and ran his own logging company for six years before his death.

An equipment operator who worked for the owner of the skidder drove the machine onto the trailer. The owner and the transporter were on opposite sides of the trailer acting as spotters for the operator. The owner was on the right side 10 to 20 feet away from the skidder. The skidder ended up with its bogie wheels uneven between the trailer's lowered flatbed deck and detached gooseneck.

As the operator tried to adjust the wheels, he inadvertently turned on the maximum speed switch on the joystick. He then activated the travel trigger, which made the skidder lurch back 9.5 feet partly off the deck into the gooseneck.

When the operator and transporter did not see the owner, they went around the trailer and found him crushed and gasping under the skidder's left tracked bogie wheels. First responders pronounced the owner dead at the scene.

- Make sure operator and spotter pre-plan vehicle movements and agree on hand signals before loading or unloading equipment on trailer. Designate one spotter to communicate with operator to avoid confusion. If visual contact is lost with the spotter, the operator must stop immediately.
- Develop your accident prevention program (APP) to include a job hazard analysis (JHA) policy that requires supervisors and workers to identify hazards for each specific type of equipment and trailer loading operation. After hazards are identified, develop and implement protective measures. Revise the JHA when changes in work plans, equipment, tools or environmental conditions introduce new hazards.

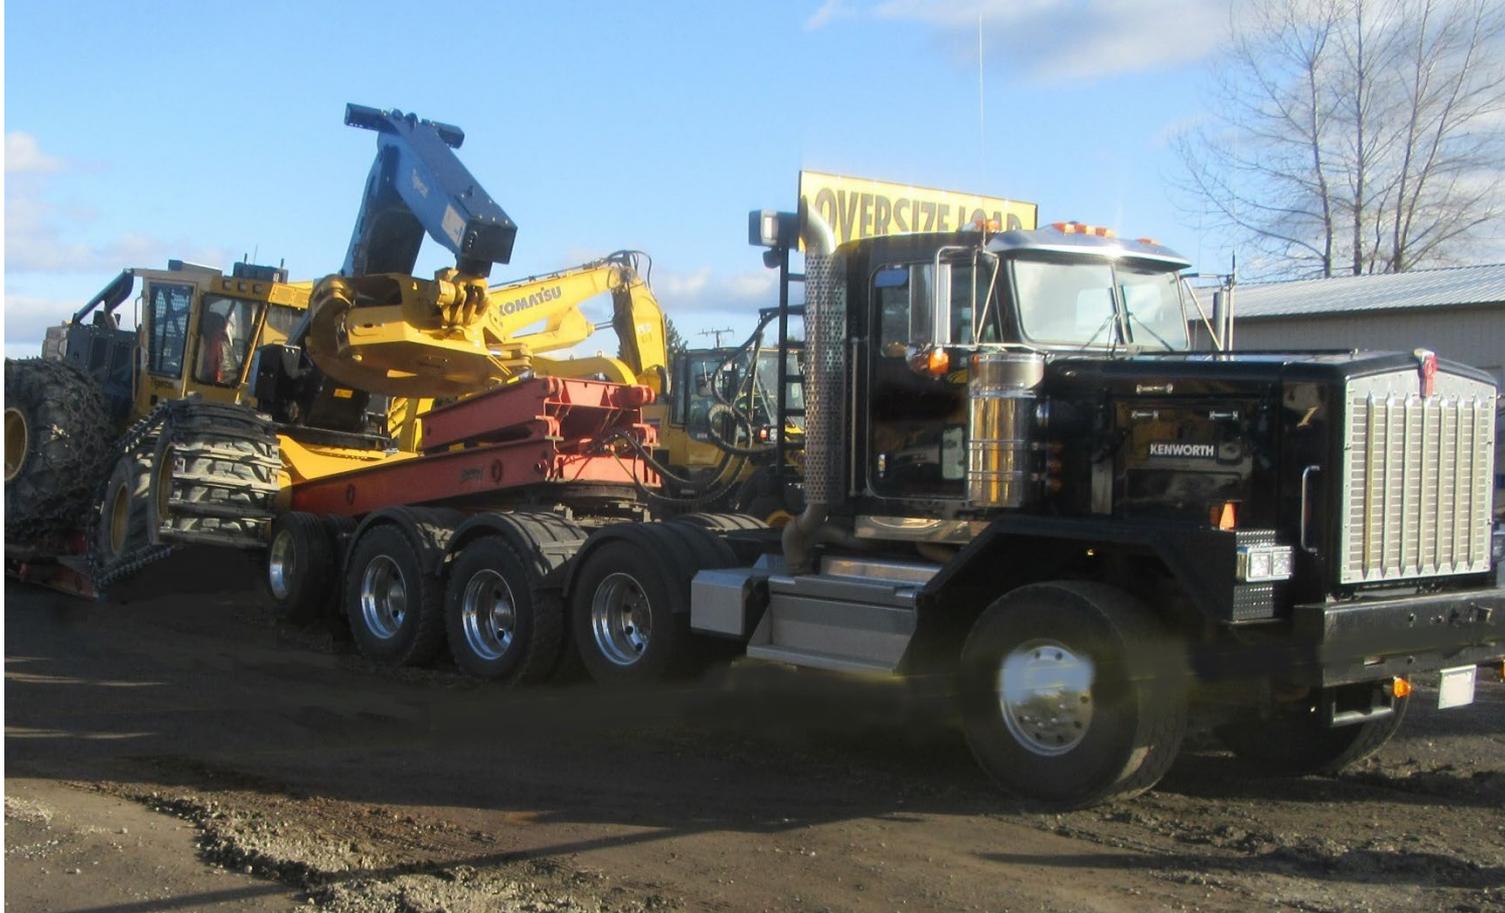
**Photo 1.** Semi-truck with skidder on detachable lowboy flatbed trailer in rear.

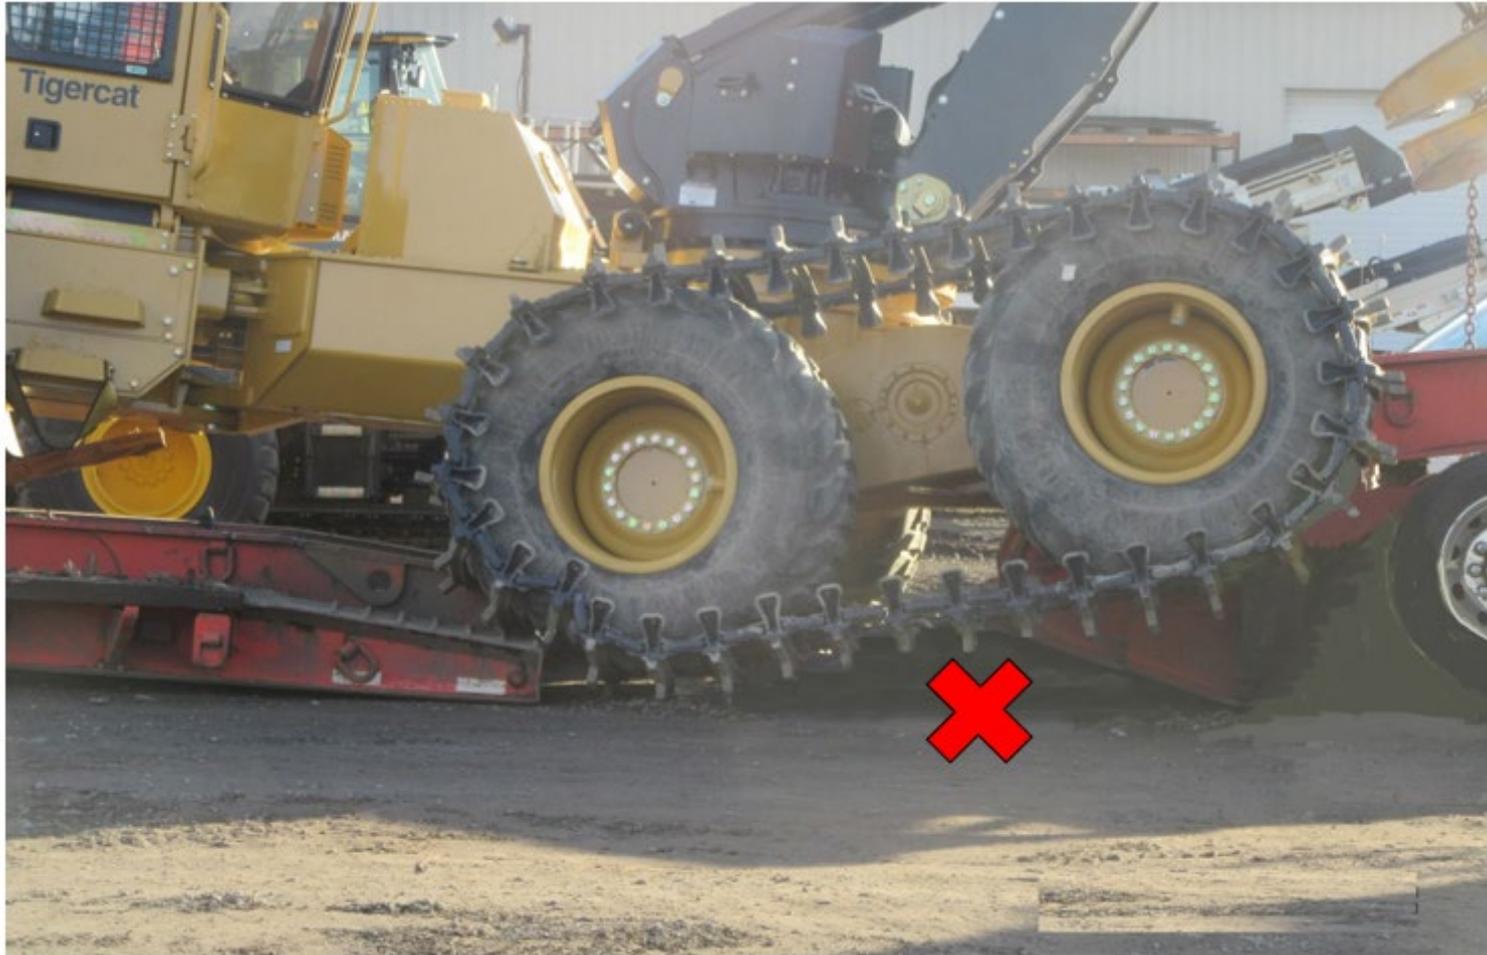
**Photo 2.** The owner was crushed under the skidder's tracked bogie wheels (X).

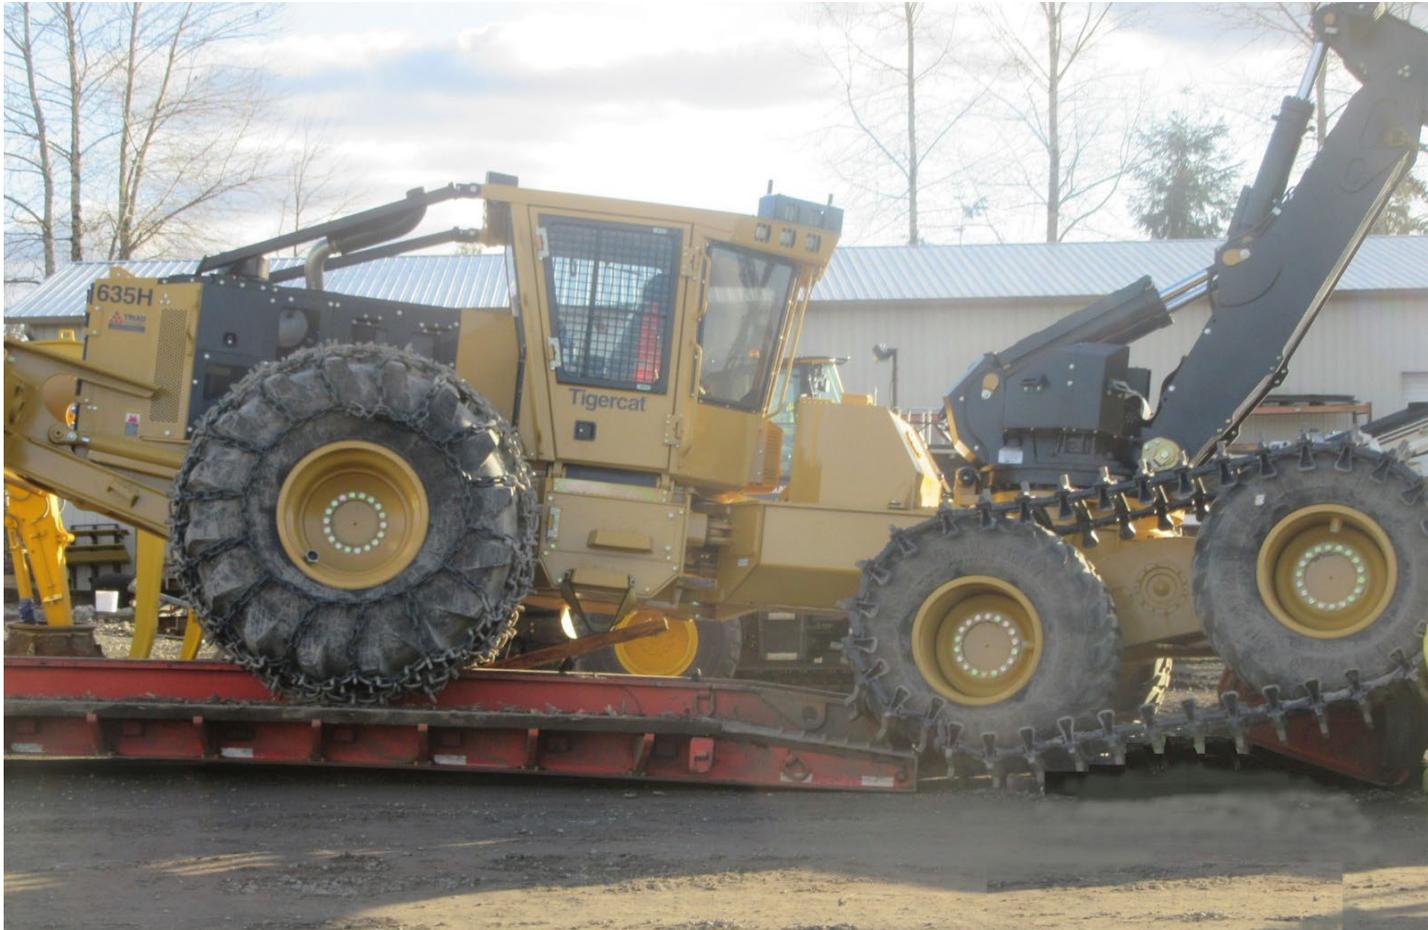
**Photo 3.** Skidder with tracked bogie wheels between lowboy trailer's lowered flatbed deck and detached gooseneck.

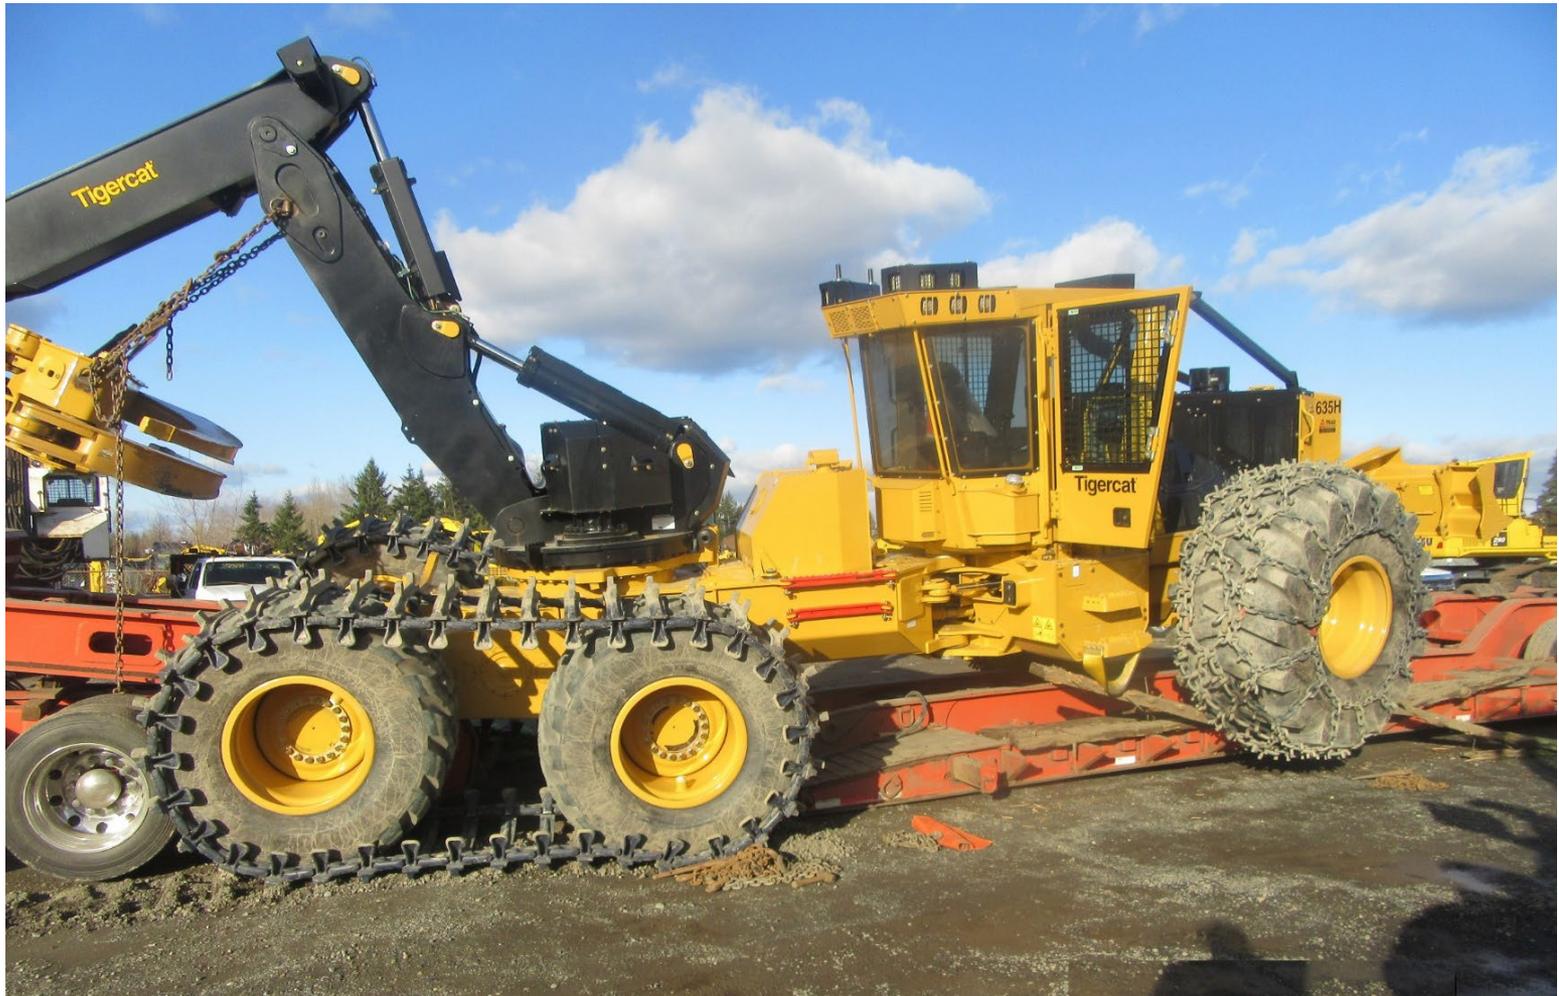
**Photo 4.** Right side of skidder after it lurched off flatbed deck into trailer gooseneck.

- Never allow heavy equipment operators to load or unload any machine on a trailer unless they have been properly trained, evaluated, and certified to operate the machine.
- Train spotters how to identify and stay out of vehicle blind areas, remain visible to operators, approach vehicles, avoid distractions, and keep a safe distance between themselves and moving vehicles.
