INCIDENT FACTS

71-267-2025

Experienced Operator Crushed in Tractor Rollover

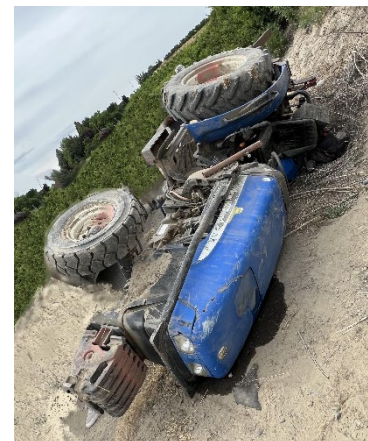
- The tractor's rollover protective structure (ROPS) was in the down position, the seat belt was installed but was not being used, and the rear wheel split brakes were not engaged.

Tractor with ROPS folded down at rollover scene.

- Provide a ROPS for each employee-operated tractor that is covered by [WAC 296-307-080](#). ROPS used on wheel-type tractors must meet the test and performance requirements of [OSHA 1928.51 C.F.R.](#). See [WAC 296-307-08009](#)
- Where ROPS are required by [WAC 296-307-080](#), employers must provide safe seat belts and make sure workers use them according to the requirements of [WAC 296-307-08012\(1\)\(b\)](#).

- Request assistance for ROPS and seat belt rules by calling their [local L&I safety consultant](#).
- Develop clear policy requirements for ROPS and seat belt use and tractor operator safety training in their written APP. Review requirements with supervisors and operators at safety meetings.
- Provide documented, hands-on tractor operator training, including recurrent refresher training.
- Provide ample supervision of tractor operators and always enforce APP policy requirements.
