AGRICULTURE FATALITY NARRATIVE

Experienced Operator Crushed in Tractor Rollover

REPORT #: 71-267-2025s

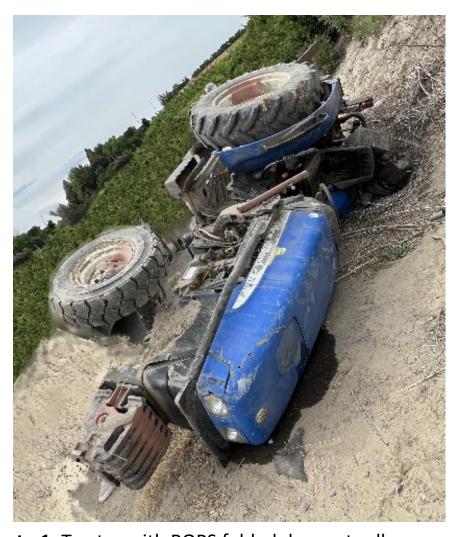
- The tractor's rollover protective structure (ROPS) was in the down position, the seat belt was installed but was not being used, and the rear wheel split brakes were not engaged.
- The employer did not ensure the operator was using the ROPS and seat belt as required. The employer thought the tractor met a ROPS requirement exemption after mistakenly believing it was a low profile tractor and because the orchard had large trees where vertical clearance requirements would interfere with harvesting operations. Evaluation and measurements of the tractor determined it was not low-profile and not exempt from the requirement to have the ROPS up at all times. Not wearing a seatbelt with ROPS increases risk of serious or fatal crushing injuries if a rollover occurs.

Photo 1. Tractor with ROPS folded down at rollover scene.

- Request assistance for ROPS and seat belt rules by calling their local L&I safety consultant.
- Develop clear policy requirements for ROPS and seat belt use and tractor operator safety training in their written APP. Review requirements with supervisors and operators at safety meetings.
- Provide documented, hands-on tractor operator training, including recurrent refresher training.
- Provide ample supervision of tractor operators and always enforce APP policy requirements.

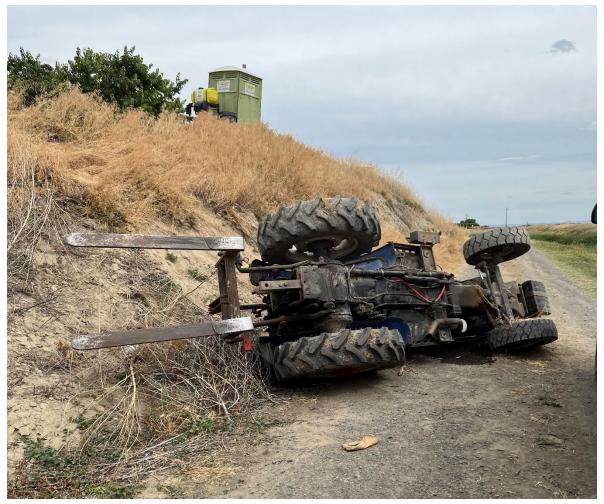
The operator was driving the tractor to move cherry bins from orchard rows to a landing deck where they would be loaded onto trucks. The tractor had pallet forks attached to its 3-point hitch. The operator was traveling near the edge of a steep, 12-foot earthen embankment at the end of the rows. He appeared to take a left turn before attempting to back into a row to pick up bins. As he turned, the tractor slid in soft soil, rolled over the edge, and trapped the operator under the left rear tire.

Photo 2. Tractor at base of embankment.

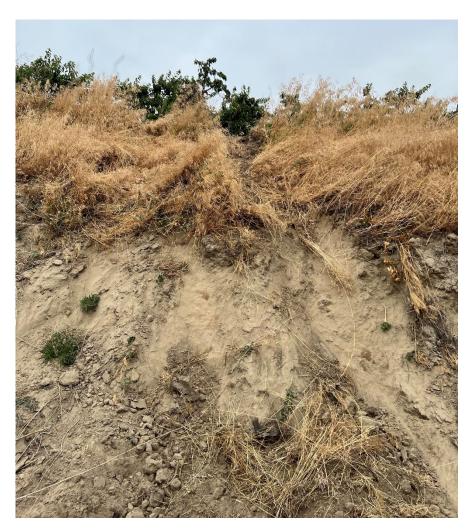
Photo 3. Side of embankment where tractor rolled over.

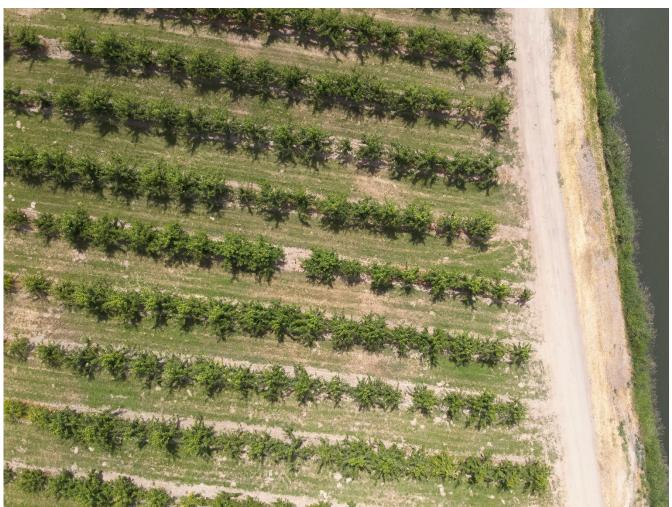
Photo 4. Aerial view of embankment road at end of orchard rows.
