Forklift Operator Dies When Crushed between Forklift Overhead Guard and Mast

Investigation: # 12WA015
Release Date: January 22, 2018
SHARP Report: # 52-42-2018

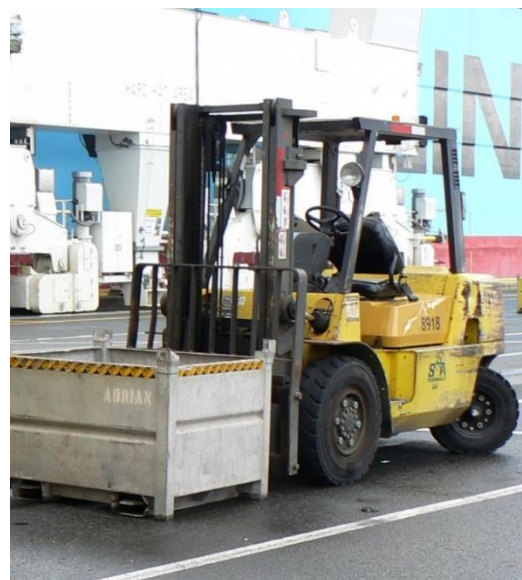
The piece of equipment involved in the incident was a gas powered forklift manufactured in 2003 by Mitsubishi, model FD 40K (photo 1). The employer purchased the forklift new. It had a load capacity of 8,000 pounds. It was properly maintained and fully functional with all of the required warning stickers, information plates, and operator restraints. The forklift had three hydraulic lift control levers used to adjust the forklift mast and forks. These levers were located behind the dash and to the right of the forklift's steering wheel. The lever closest to the steering wheel moved the forks up or down. The middle lever, when pulled down, tilted the mast

Photo 1: Employer forklift similar to the incident forklift with a cone bin on the incident dock.

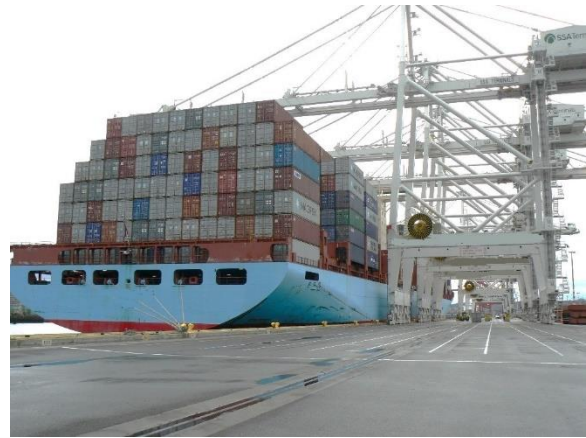
The incident took place at a marine port terminal dock (photo 2).

Photo 2: Port terminal dock with ship loaded with shipping containers.

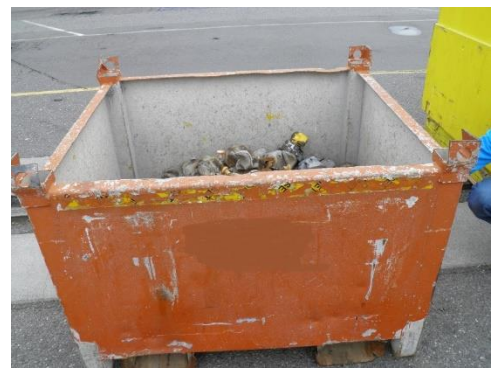
Photo 3: Cone bin.
