# Orchard Worker Driving Overloaded ATV Struck on Highway

**REPORT #:** 71-223-2022s

**REPORT DATE:** July 13, 2022

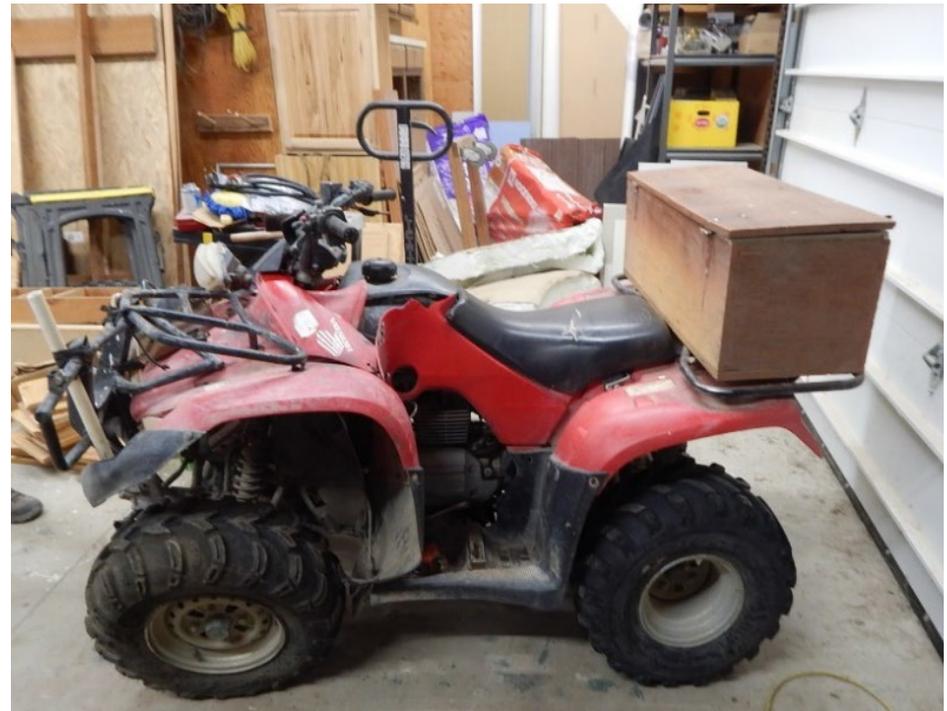
A 40-year-old orchard worker was driving a four-wheel drive all-terrain vehicle (ATV) when he was struck by a vehicle on a state highway. The incident occurred around 1:35 p.m. The worker was using the ATV to bring PVC pipe to an orchard where an irrigation line had to be repaired.

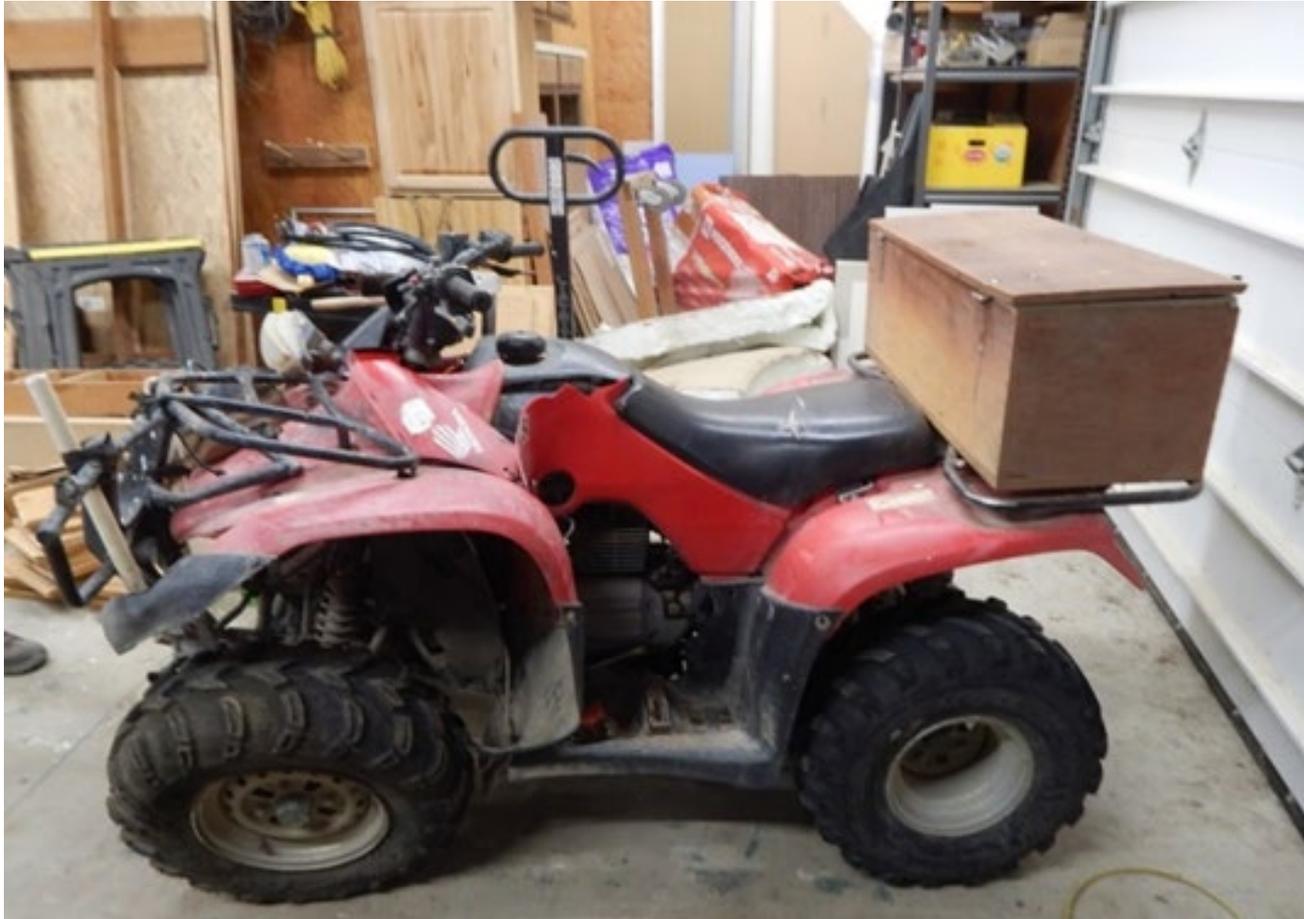
**Photo 1.** All-Terrain Vehicle (ATV) with damage from a collision with a horse trailer.

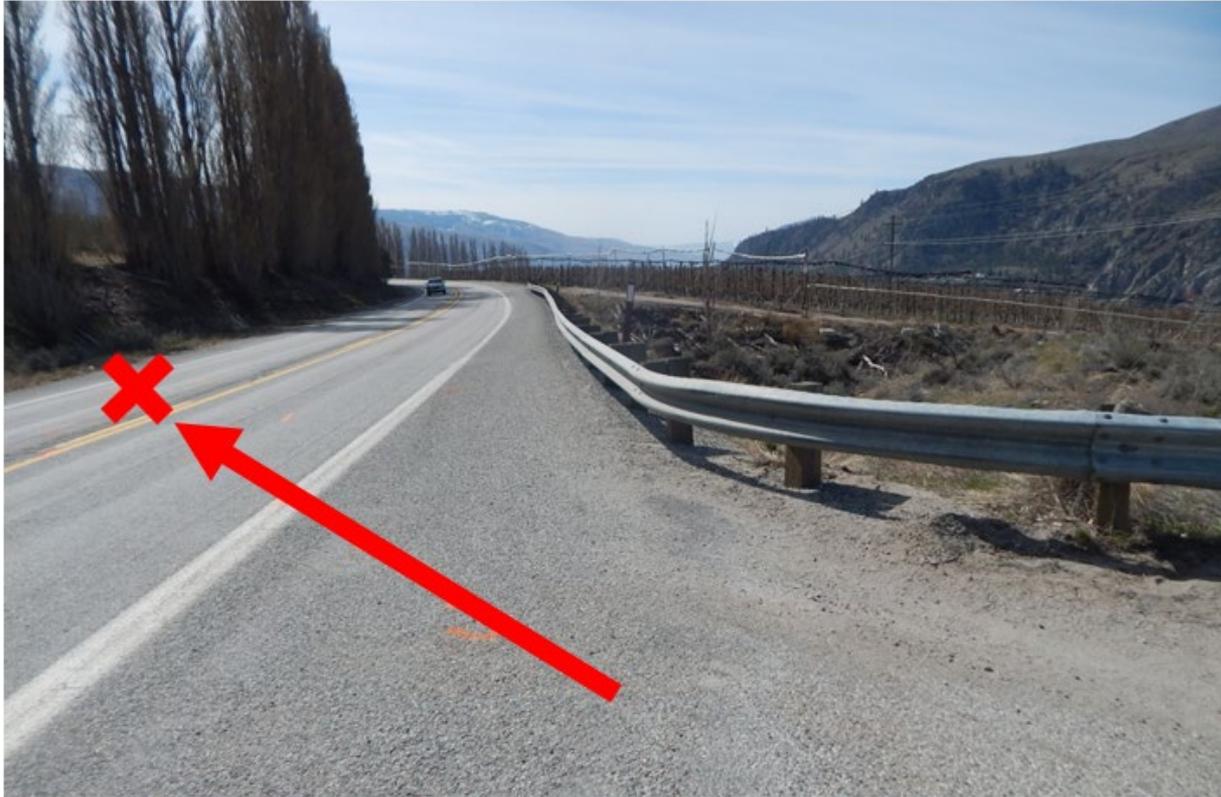
On the way to the orchard, the two workers drove on a gravel access road to an intersection with a paved state highway. The road had a slight decline where it met the highway. The worker with the pipe was in the lead. He tried turning right from the road onto the highway's southbound shoulder but lost balance and control from the momentum and pipe blocking his steering ability. He rolled across the centerline into the northbound lane where an oncoming passenger truck going the 60 mph speed limit struck the ATV with the left front side of a horse trailer it was towing. The worker was ejected from the ATV and died at the scene.

**Photo 2.** Intersection of orchard access road and state highway where orchard worker lost control of overloaded ATV after attempting to turn onto the right southbound shoulder. Arrow shows path of ATV travel after losing control. X shows where horse trailer struck worker's ATV in northbound lane of state highway.

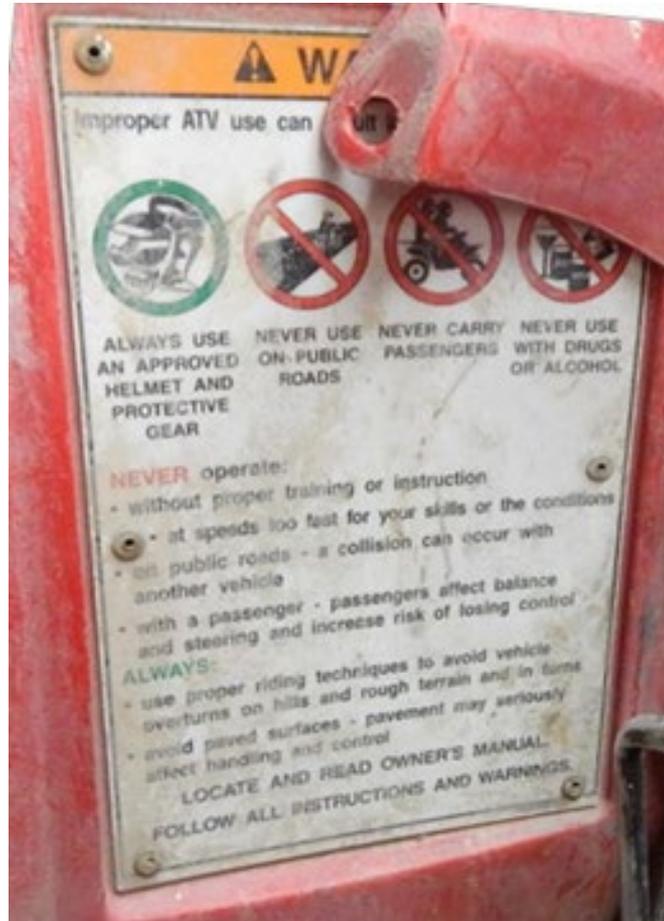
- The employer did not ensure that workers followed the ATV manufacturer's guidelines to not have any loads that were not secured to the vehicle's front and/or rear cargo racks.
- The employer did not provide helmets nor ensure that workers wore them per manufacturer's guidelines.

- The employer did not prohibit workers from driving ATV on highways and public roads, including shoulders, in accordance with state vehicle and traffic rules and vehicle manufacturer's guidelines.
- The employer did not ensure that workers were provided with proper hands-on ATV safety training.

**Photo 3.** Manufacturer's warning label on ATV showing helmet requirement and public road use restriction.

- Provide DOT-compliant helmets and develop APP requirements and training for ATV, UTV, and other off-road vehicle operators to wear them during vehicle operation.
- As part of their APP, do a job hazard analysis (JHA) of tasks involving farm vehicles and equipment that may pose risks. Workers should be involved in creating the JHA.

- Develop APP policy requirements and safety training for ATV, UTV, and other off-road vehicle operators to follow manufacturer's safety guidelines, including loading procedures, and state, county, and local vehicle and traffic laws and ordinances.
